# Ask Joe Powder

## Coming Clean on Contamination

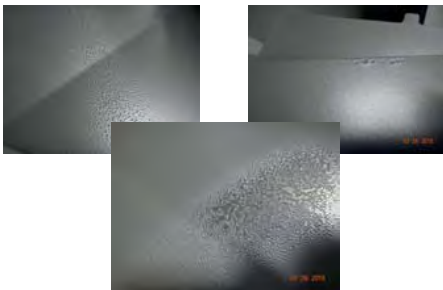
I have a weird problem, and I am unable to find a root cause yet. In attached picture you will see a defect on some of the trays we paint with silver metallic having aluminum in it. On a particular area, we get this defect and occasionally on the edges. We thought it might be cleaning issue, but there is an excellent adhesion. It doesn't happen all the time nor with all parts but with majority of it.

We thought it might be back ionization issue but we painted 100 trays and inspected each one of them prior to going into the oven (each of them was perfect) and 18 came out with this defect.

"Mysterious" Coating Defects - Is it Back Ionization or Surface Contamination?

**A** It's always nice to hear from you, but maybe not so much under these circumstances. This doesn't look like back-ionization to me. I think it's a foreign substance on the metal surface. These defects look like a surface tension issue. Something like a high molecular weight lubricant or wax. I would scrutinize your cleaning/pretreatment system and ensure that you are thoroughly removing all soils, oils and lubricants from the surface of the parts. You can use the time-tested water break test. If water beads

up on any part of the surface then there is an oily or waxy residue on the part. Removal usually can be accomplished by a well-controlled cleaning process. This means the right temperature, concentration and cleanliness of your cleaning solution.
